WHAT HAPPENED?

KEY LESSON FROM INCIDENT

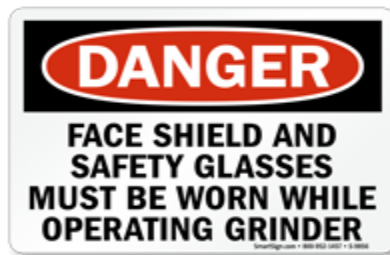
An employee attempted to sharpen a chisel with a bench grinder. He started to sharpen the chisel when the grinding wheel exploded into many pieces flying in all directions. Luckily there were no injuries. The employee was NOT wearing proper Personal Protective Equipment (PPE) and the grinder's safety shield had been removed.

The Employee felt he was only going to use the grinder for a short time so he did not inspect the grinder and did not bother putting on the proper PPE.

Never take short cuts, just because you are only using the grinder (or any tool) for a short time. You should follow all safety rules and practices such as PPE and Inspection requirements.

- Ensure grinding wheels are inspected (check for cracks, is the grinding wheel tight, etc.)
- Ensure the grinding wheel is the correct wheel for the grinder, (RPM's and wheel size)
- Ensure tool rest (guarding) is within 1/8in (3mm) of the wheel

-Ensure Proper PPE is worn when using grinder: Eye protection (safety glasses and full face shield), Gloves and Hearing protection
