WHAT HAPPENED?

KEY LESSON FROM INCIDENT

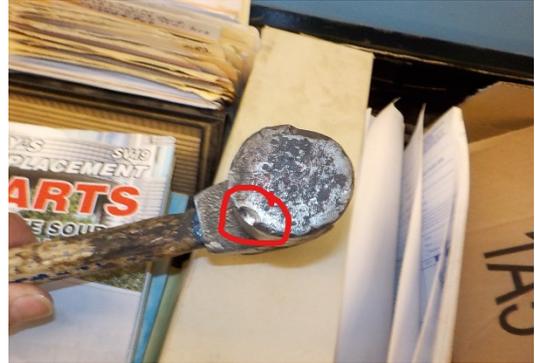
A boat trailer had come into the shop for suspension repairs as it had lost a wheel. The technician removed a bent suspension mounting bracket and was hammering the bracket straight with a ball peen hammer and a steel wedge block when the incident happened. On his third strike of the bracket, a chunk of steel from the hammer's face broke off and penetrated the technician's coveralls and torso, lodging in an artery. First aid was being administered when the seriousness of the injury was determined and 911 was called for an ambulance.

During the investigation, the company found the hammer's face had previously been damaged and had stress risers in certain areas. The company's immediate response to this incident was to inspect all hammers. (ball peen, sledge etc.) They found several hammer faces to have unacceptable wear patterns as well as damage to the handles. The company also inspected their chisels, pry bars and any tool that would be used in conjunction with a hammer. Any questionable hammers were disposed of and replaced with new brand CSA approved hammers (not the cheaper import hammers).

The company has since developed a policy that requires anyone that's using a hammer or grinder to wear a leather apron and full-face mask and gloves. The company has also implemented an inspection process to ensure all hammers and tools are being inspected prior to use, as well as once a month during their monthly shop inspections.

This incident demonstrates the importance of inspecting your tools and equipment prior to being used, as well as knowing and practicing your Company's Emergency Response Procedures. Seconds can be the difference between life and death, so know what you need to do in the event of an emergency situation.
